Straw-Bale Construction

A Review of Testing and Lessons Learned To Date

by Bruce King, C.E.

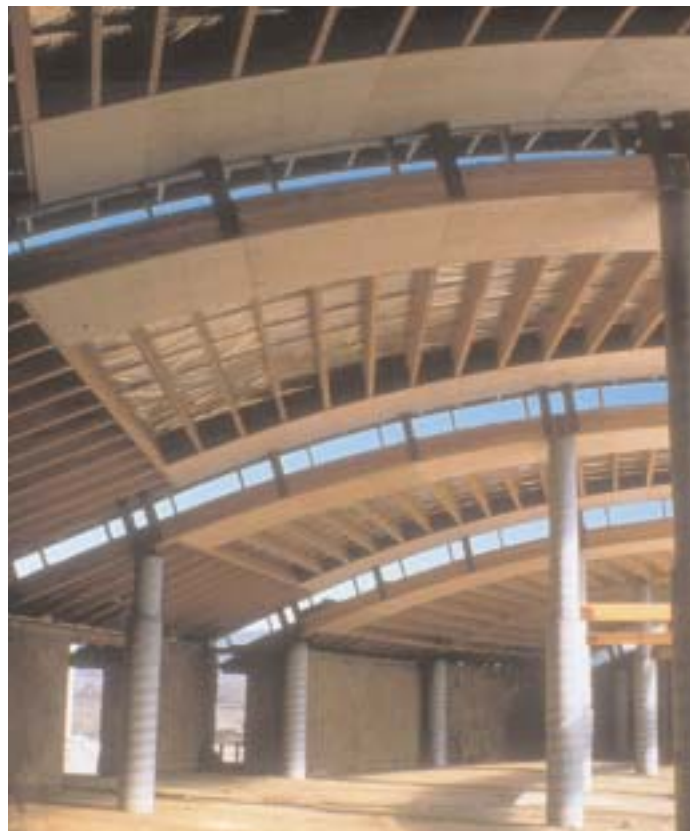
The Real Goods Solar Living Center in Hopland, California, is constructed of straw-bale and employs passive solar heating and cooling, daylighting and energy efficient lighting and equipment, a utility grid with photovoltaic and wind electricity generation, an outdoor oasis cooled by evaporation immediately adjacent to the building, and greywater irrigation.
