BUCKHORN GEOTECH
Consulting Engineers & Geologists
245 So. Cascade Ave. Montrose, Colo. 81401
(303) 249-6828 FAX (303) 249-2768

ENGINEERING EVALUATION OF EARTH-FILLED TIRE CONSTRUCTION
DENNIS WEAVER RESIDENCE
RIDGWAY, COLORADO

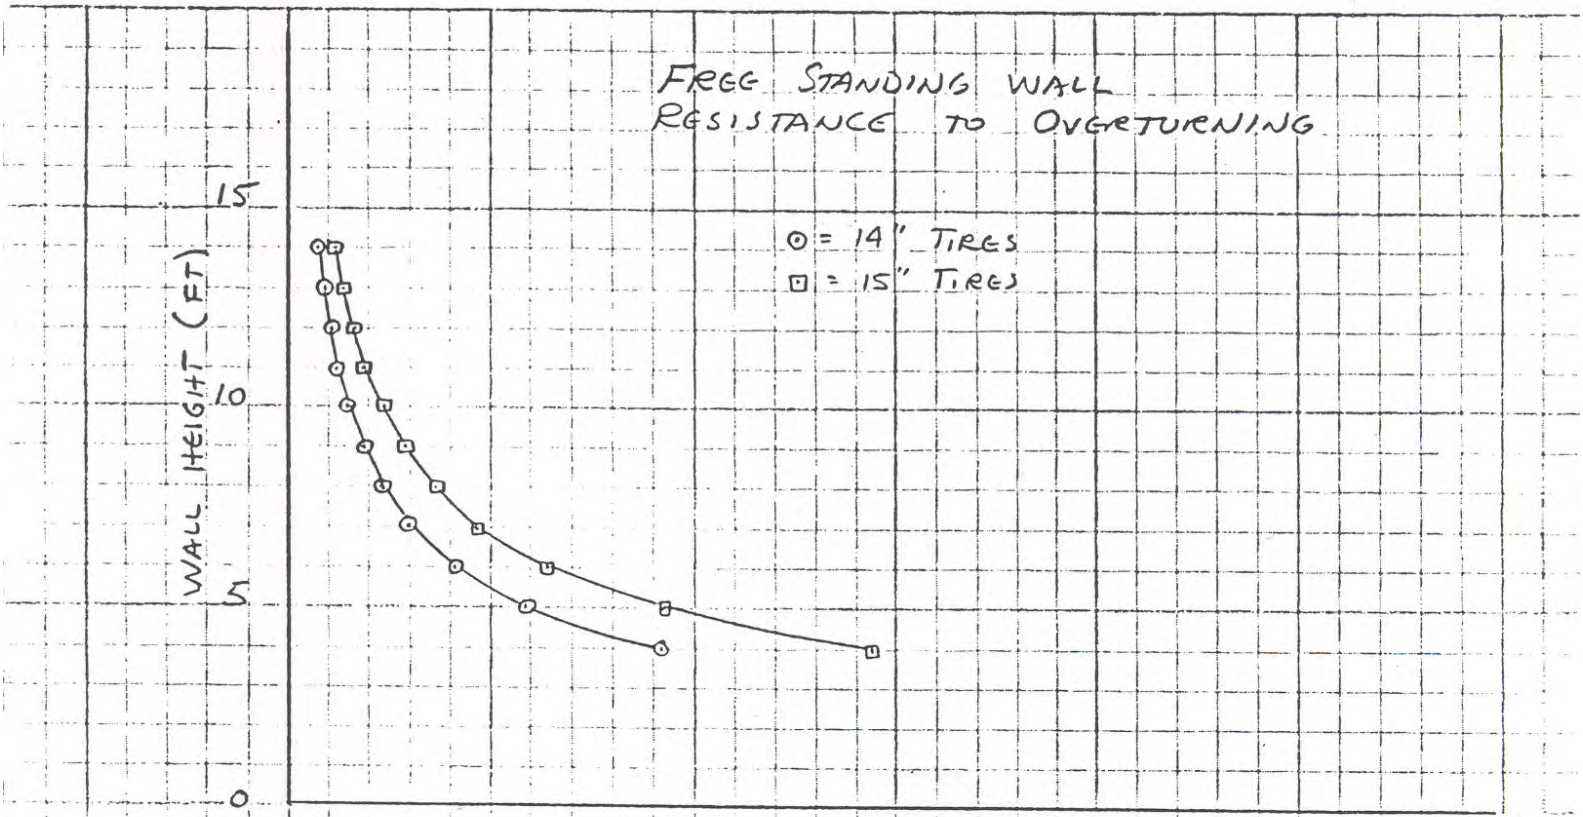
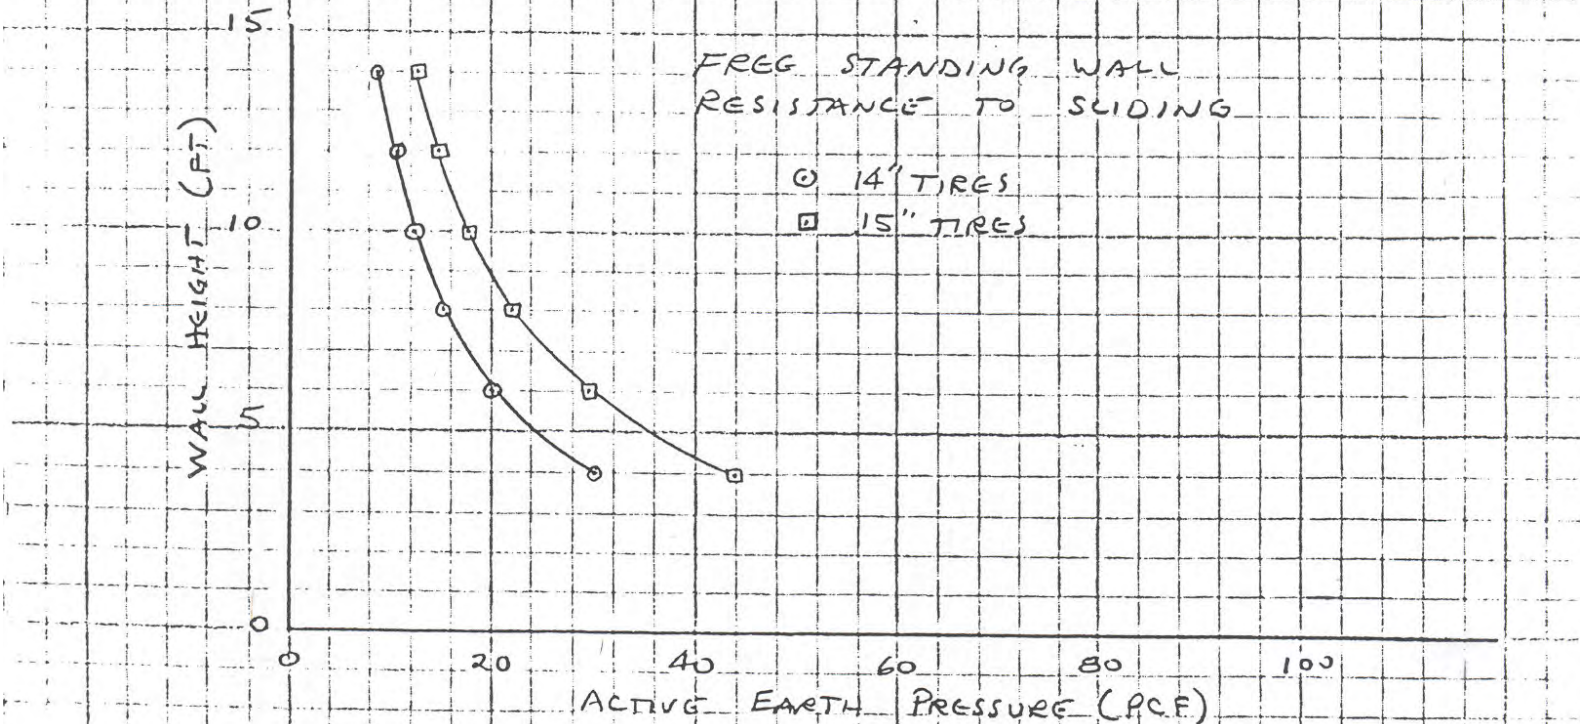
FIGURE 1.

Two mathematical models of a free-standing tire wall retaining earth on one side have been established. The models represent equilibrium between active earth pressures behind the wall which act to cause the wall to overturn or slide, and the forces of gravity and friction which cause the wall to resist the sliding and overturning forces. The results of the calculations are shown as curves in Figure 1. The curves represent the amount of lateral earth pressure, expressed as a fluid equivalent, that will just cause a wall of the corresponding height to overturn or slide. It was found that walls under 5-feet high made of 14-inch

tires will fail by sliding while walls over 5-feet in height are more apt to overturn. Walls made with 15-inch tires hold the same relationship but the crossover height is about 6 feet. The lateral earth pressures developed by soil can be determined by a soils testing laboratory. They can vary considerably with a general range of 25 to 30 pounds per cubic foot (pcf) for coarse sand and gravel to over 75 pcf for soft silts and clays. The curves of Figure 1 show that a 14-inch tire wall would generally be suitable for a height of up to 4 feet while a wall constructed with 15-inch tires may be stable to a height of 6 feet.

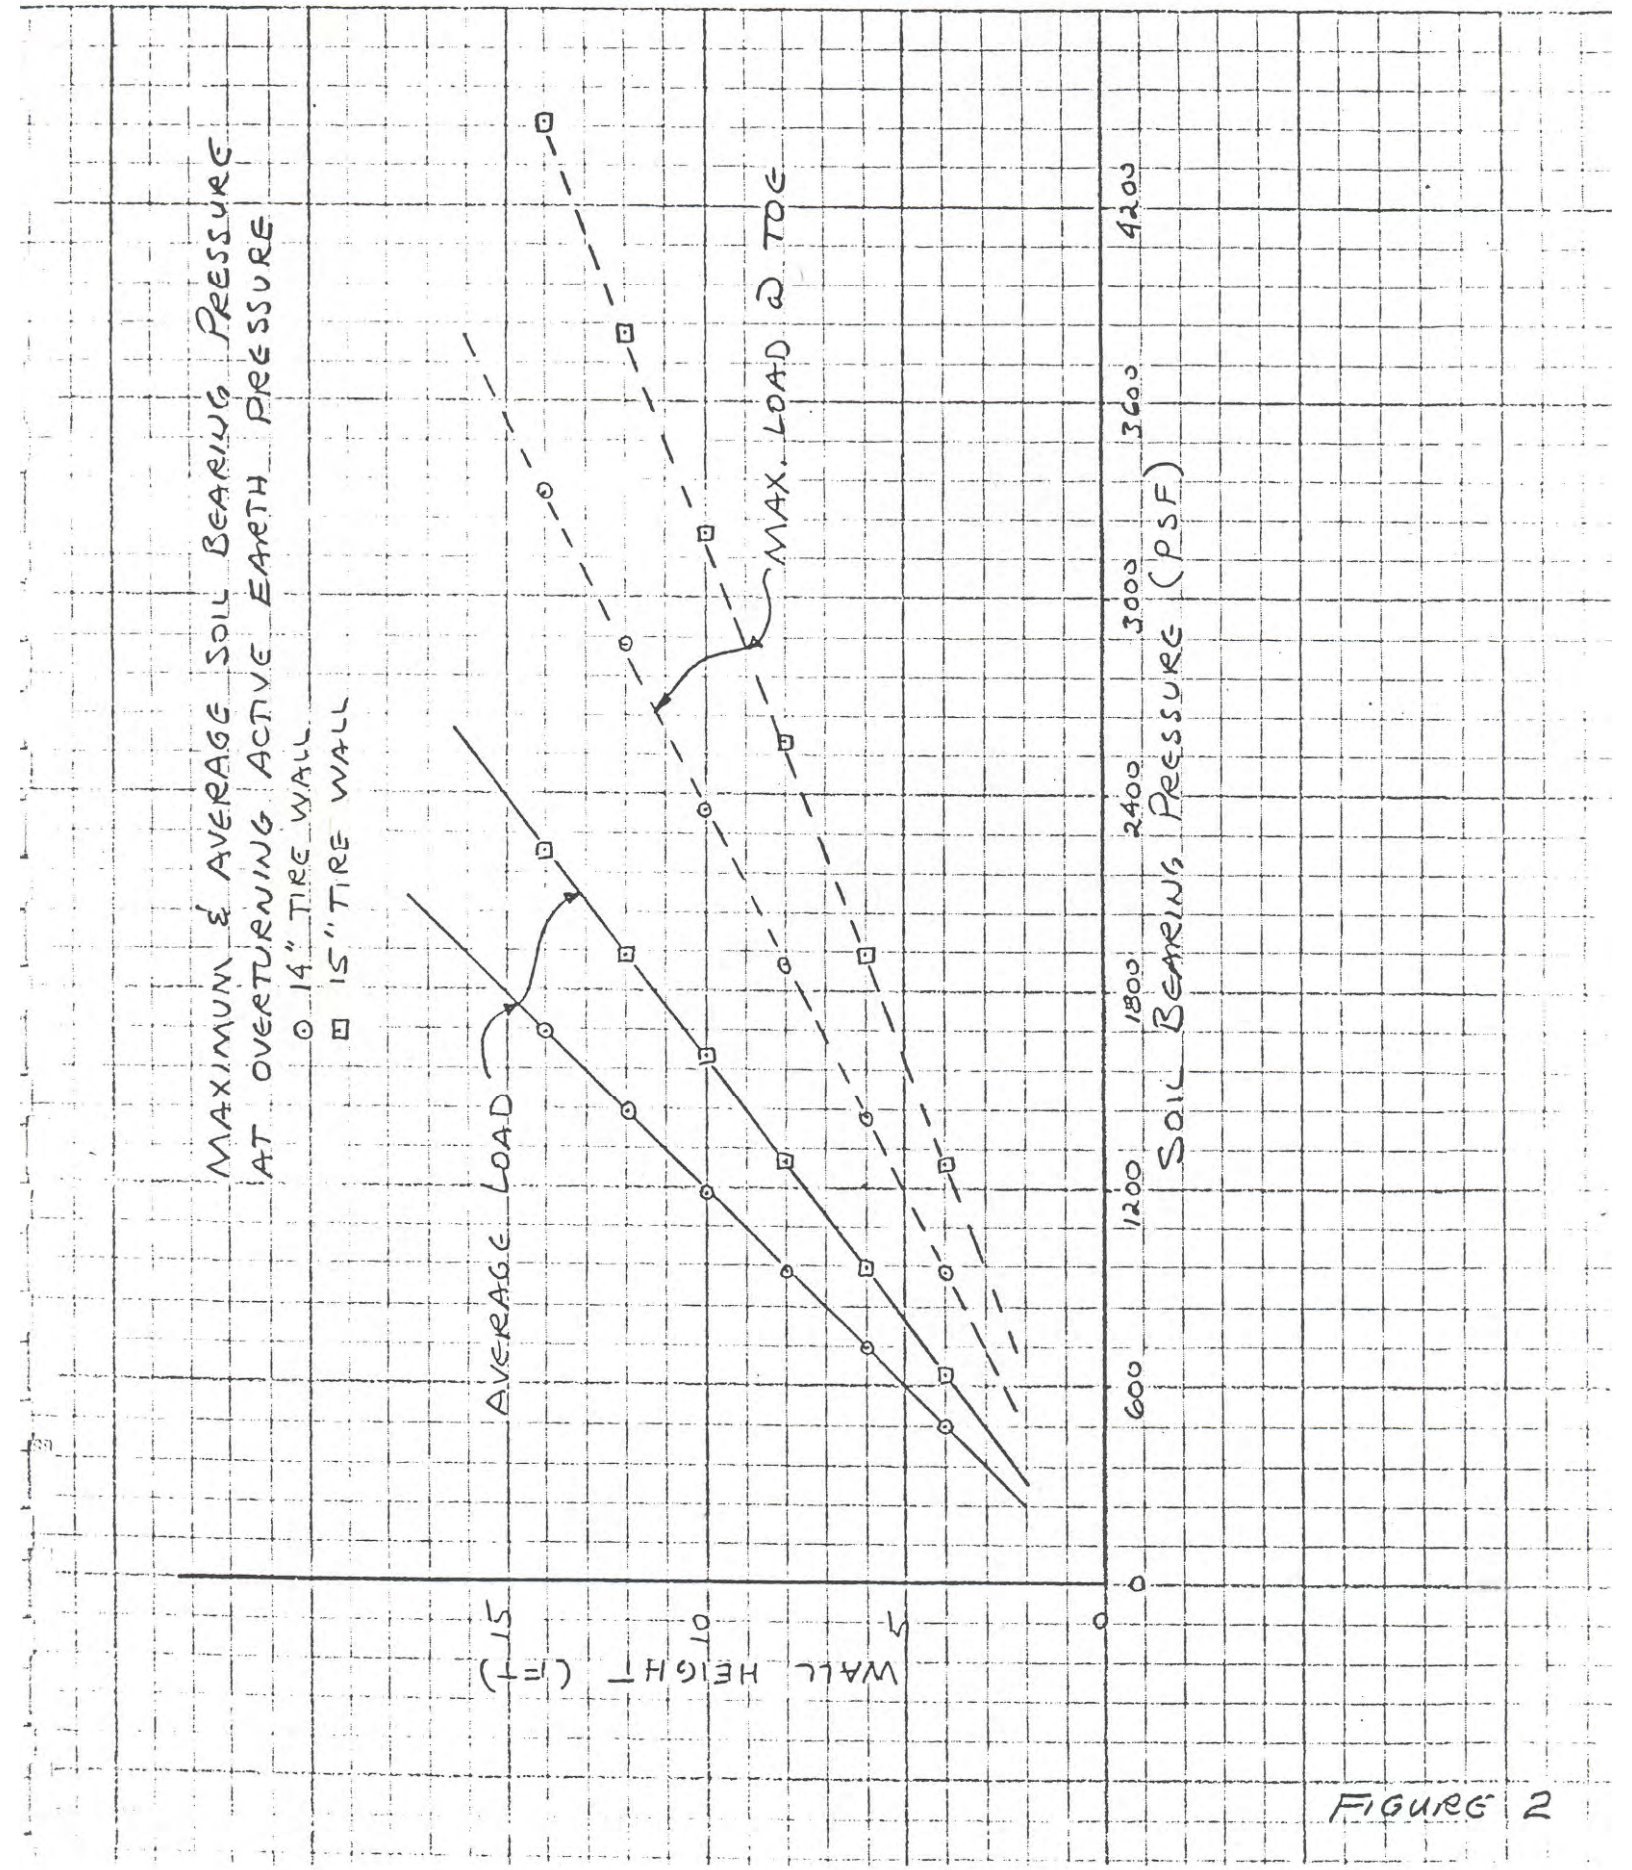
FIGURE 2

The weight of a tire wall and the overturning moment imparted to the wall by lateral earth pressures create a load on the soil beneath the wall. These soil bearing pressures have been calculated for a free standing wall and are shown in Figure 2. Two curves are shown for both 14-inch and 15-inch tires. They represent the maximum pressure under the outside edge or toe of the tire wall and the average pressure under the wall. Both curves assume that the lateral earth pressures are at a maximum for the various wall heights shown. Therefore, they represent the upper range of values to be expected under stable walls. The safe bearing pressure of a soil can be established through field and laboratory testing. At the Weaver house, the safe bearing pressure is over 2500 pounds per square foot (psf). However, it can vary in the Ridgway area from as little as 500 psf for soft silts and clays to as high as 5000 psf for gravels and dense soil mixtures.

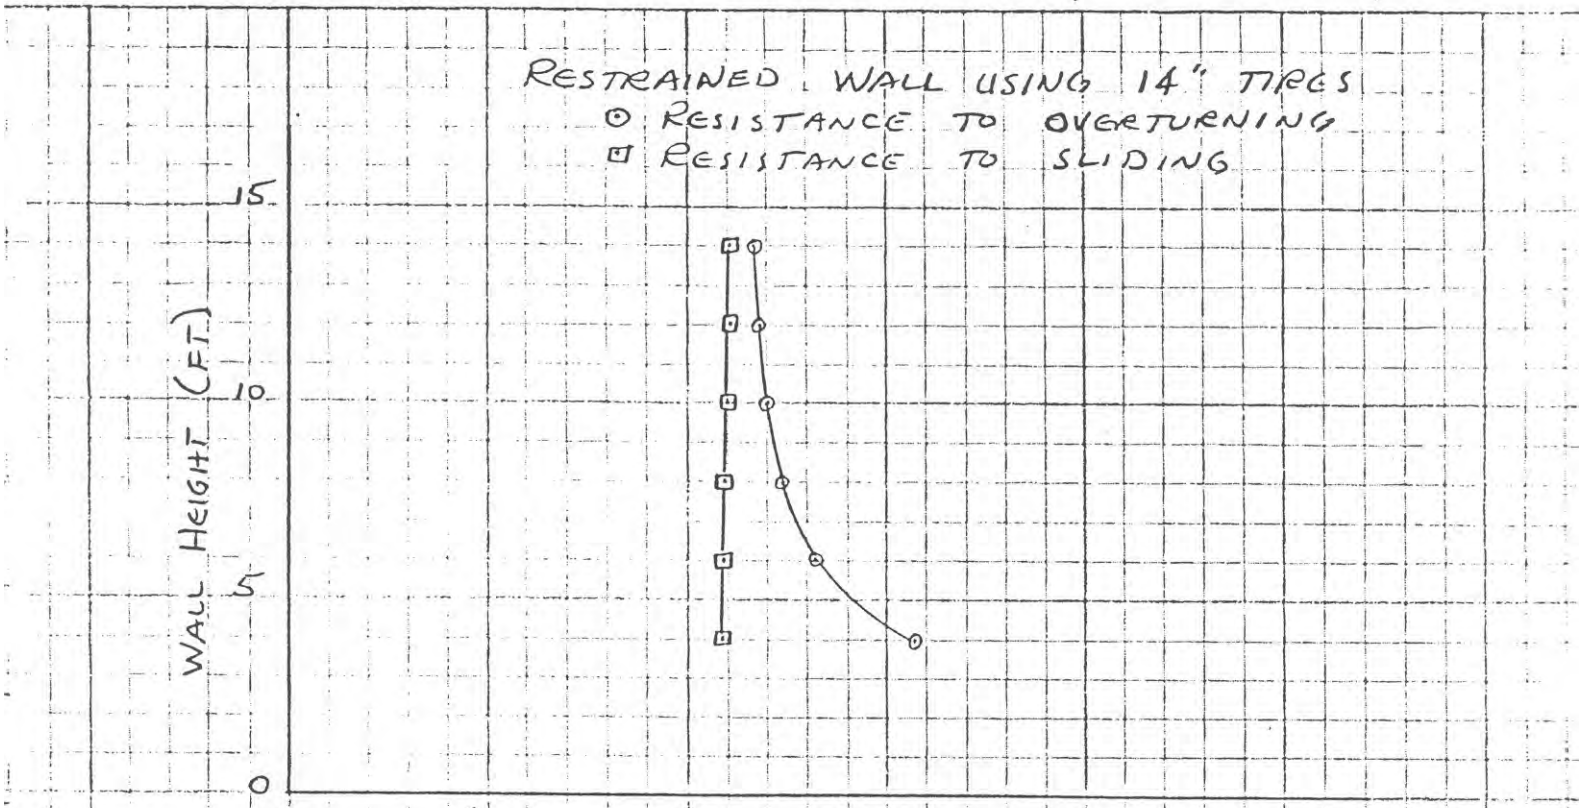
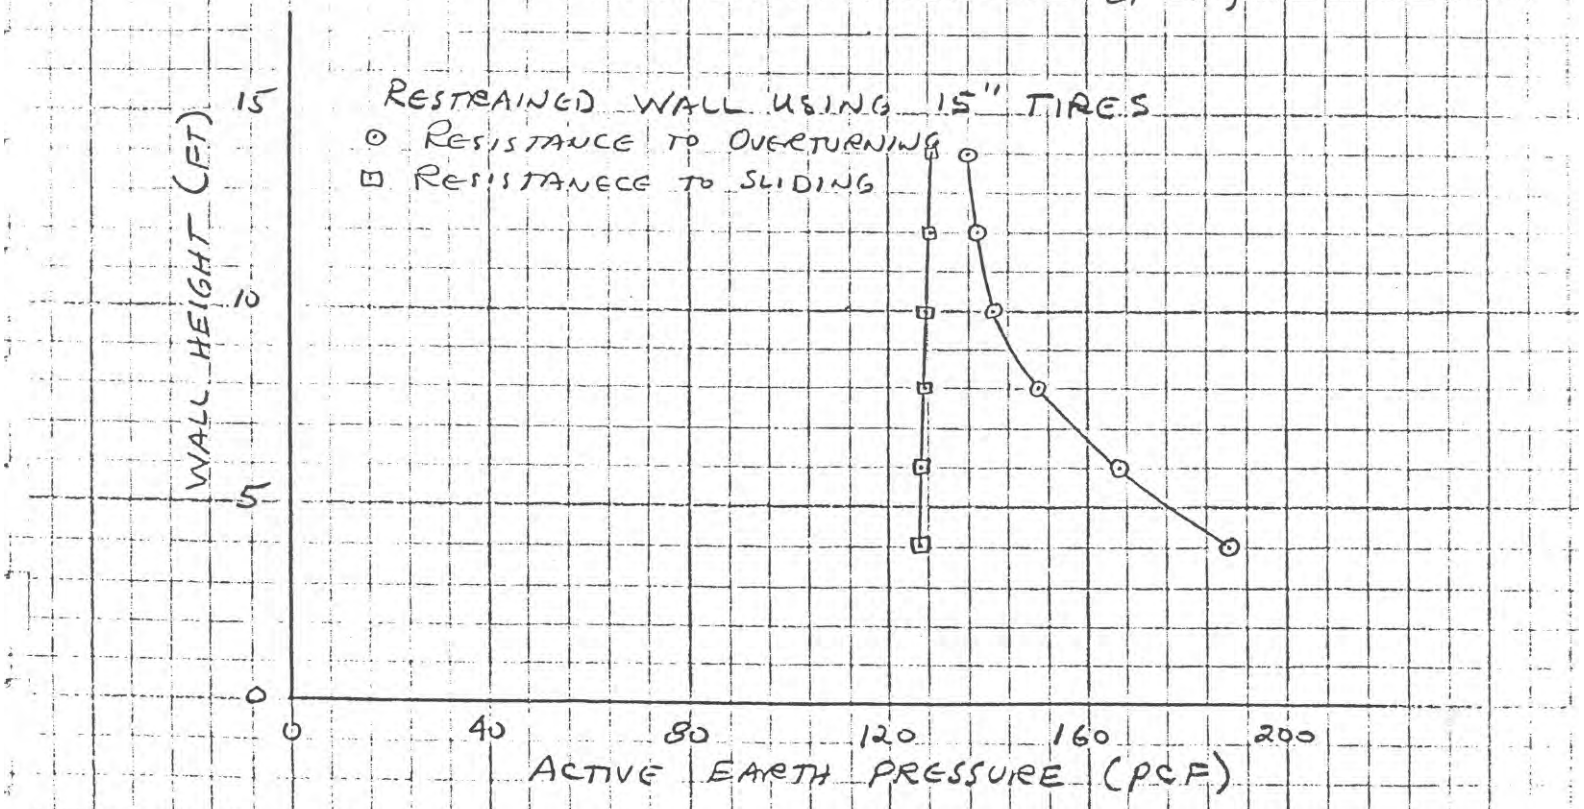
FIGURE 3

The mathematical models developed for the free standing walls were modified to incorporate the additional resistance to sliding and overturning afforded due to lateral bracing. The Weaver house has horizontal lateral bracing from the roof system and vertical bracing from the wall curve at the back of the U-shaped cells and the wall return at the corners of the two outermost walls at the open ends of the U's. This lateral bracing is transferred through the tire wall via the tire-to-tire friction developed through the overlapping tiers of tires. That is, in order for the wall to fail, movement must occur at each tire between the area of lateral bracing and the point of failure. Therefore, the frictional forces along each of those planes of movement must be overcome. This adds dramatically to the strength of the wall as shown in Figure 3. It can be seen from the curves of Figure 3 that the laterally braced walls of the Weaver house will not slide or overturn.

Although both 14-inch and 15-inch laterally restrained walls are more likely to slide than overturn, it would take lateral pressures in excess of 80 pcf to move a 14-inch tire wall and pressures of over 120 pcf to cause failure of a 15-inch tire wall. The active earth pressures at the Weaver site are expected to be in the 30 to 40 pcf range.

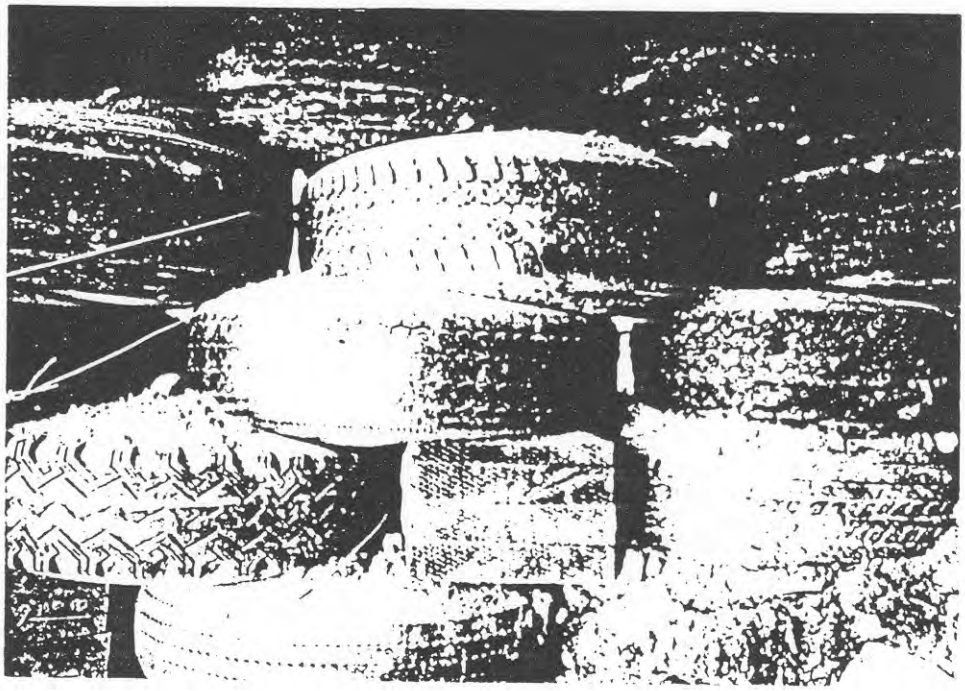
Typical Completed Wall.

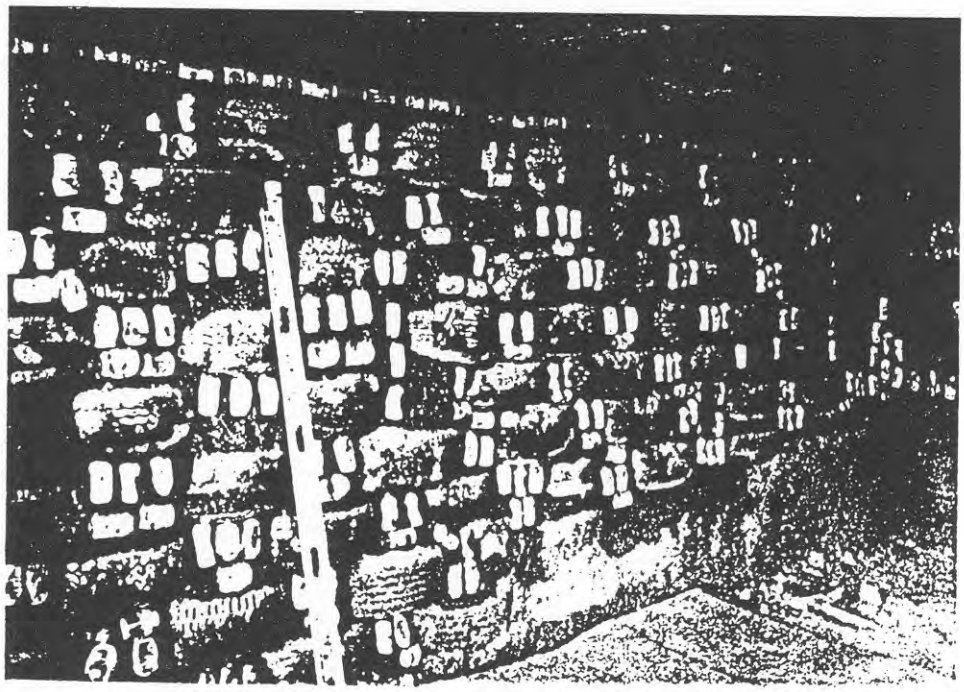
Typical Wall Before Mortar Application.
